## Examination of Suspected Delta II Second-Stage Reentry Debris

15 July 2001

P. M. ADAMS and W. H. KAO  
Space Materials Laboratory  
Laboratory Operations

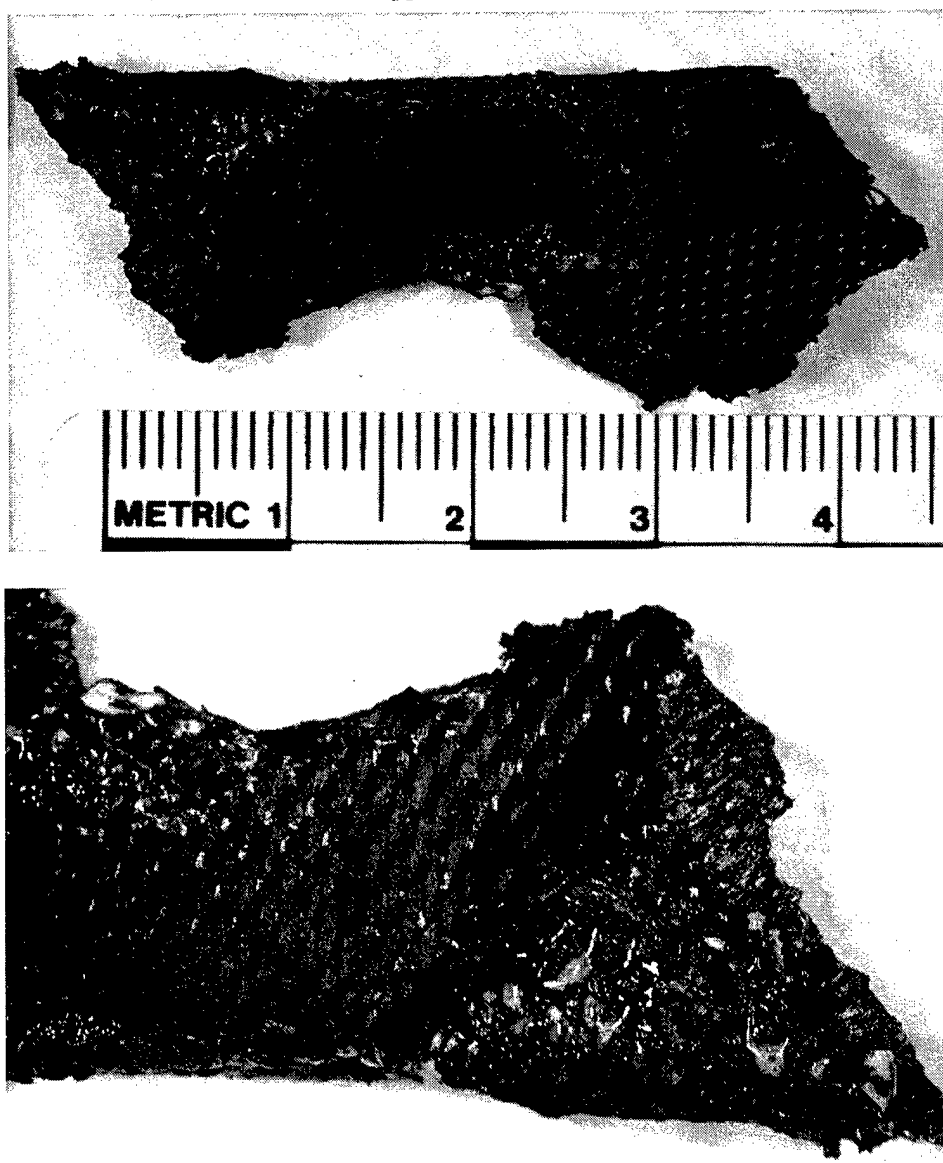
Figure 4. Optical macrophotographs of as-received debris. Upper scale bar is in cm.

Visually the material appeared to be a piece of black-colored woven fabric that was about 1.5 cm x 0.5 cm x 5.0 cm in size (Figure 4). Initially, before closer inspection and handling, it was thought to be a piece of carbon or graphite fiber cloth because of its color; however, it was very hard and brittle. Upon closer examination, it was found that the fibers were colorless, with a very dark coating, and that there were colorless fused-looking deposits that contained many bubbles (Figure 5). There were also a few small areas (1 mm x 1 mm) that appeared silvery-metallic.

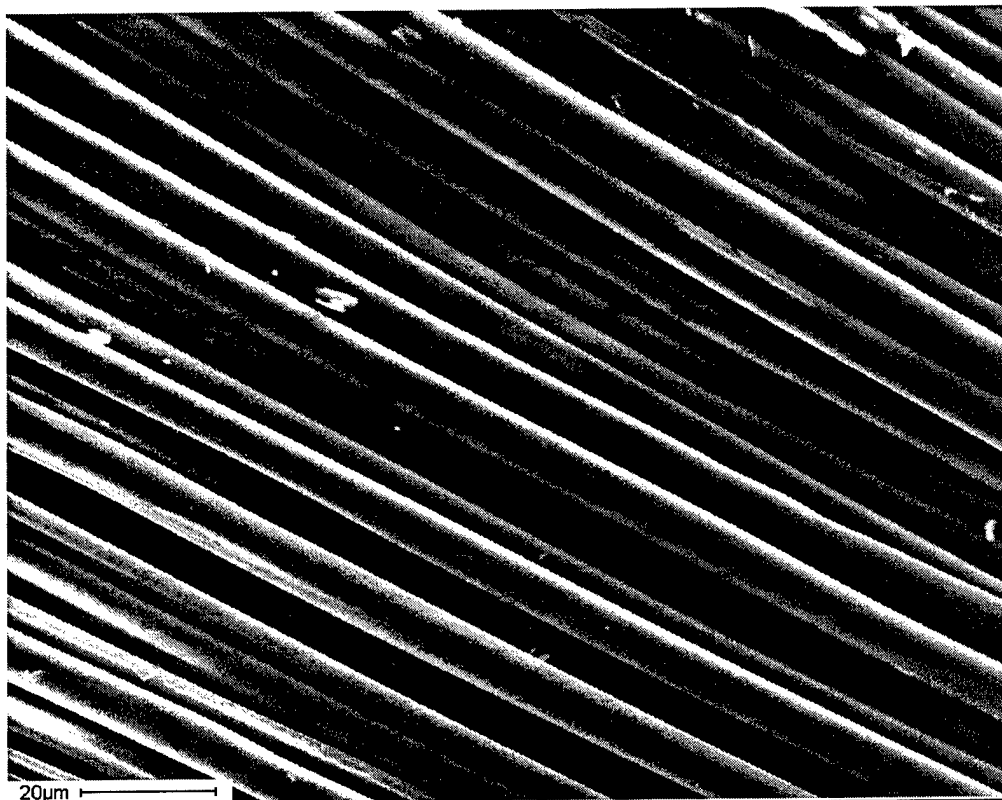
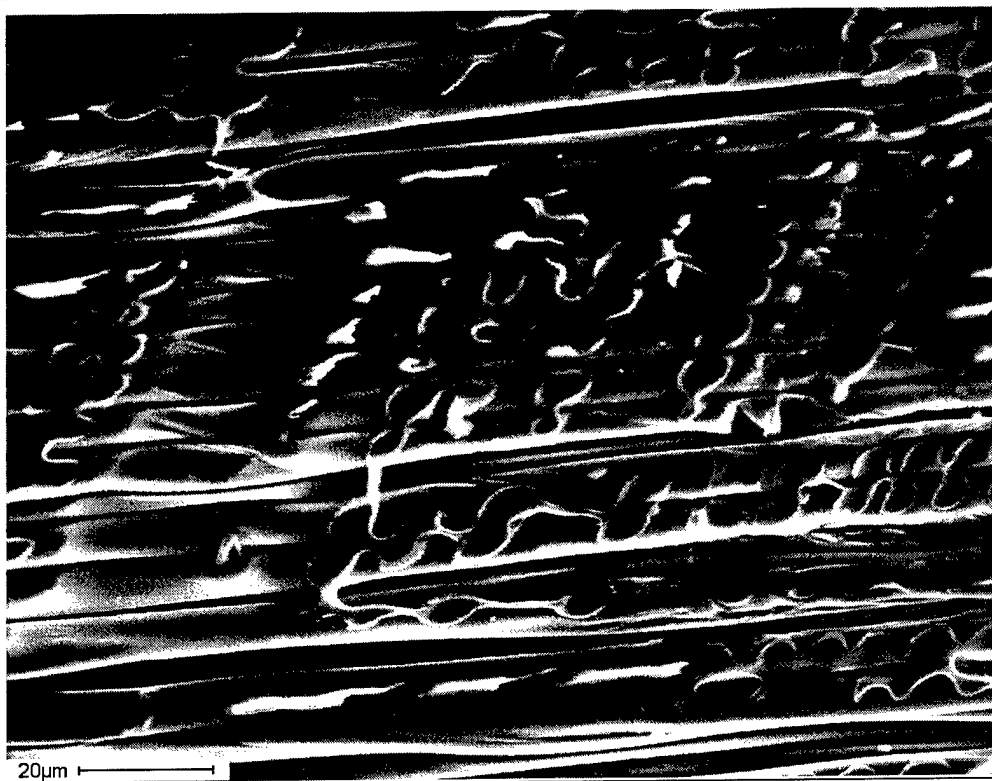
Figure 6. SEM photographs of fibers in the debris.

In the SEM, the fibers appeared very smooth, circular in cross section (about 9  $\mu\text{m}$  in diameter), and locally covered with thin deposits (Figure 6). The fused-looking areas had smooth surfaces, and in some areas bubbles were observed on fracture surfaces (Figure 7). The chemical analyses of the fibers and fused deposits indicated that they both contained primarily oxygen (O), silicon (Si), calcium (Ca) and aluminum (Al) (Figure 8), which is consistent with the material being fiberglass. It is noted that the EDXS system can not detect lithium or boron. The residue on the fibers (lower photograph in Figure 6) consisted primarily of carbon (C) (Figure 8). The metallic-looking areas had a number of different textures, which ranged from rounded-melted, to folded, to feathery-dendritic (Figures 9 and 10), which probably resulted from the melting and resolidification of the aluminum. Several of the small silvery-metallic deposits were analyzed by EDXS, and all contained primarily aluminum (Al) and oxygen in varying proportions (Figure 11); however, minor amounts of magnesium were occasionally detected. The lower picture in Figure 10 shows the dross layer, which consists of aluminum oxides and impurities, that forms on the surface of molten aluminum that is in contact with an oxidizing atmosphere for a certain length of time. The EDX spectrum from this area did show more oxygen (bottom of Figure 11) than in other metallic areas. The depth of penetration in the EDX analysis is on the order of 1  $\mu\text{m}$ . An XRD pattern of one metallic particle indicated that the bulk of the material was metallic aluminum; however, some very weak lines attributed to alpha aluminum oxide ( $\alpha\text{-Al}_2\text{O}_3$ ) were also observed. Based on the XRD and EDX analyses, it is assumed that the aluminum oxide is a thin surface layer.

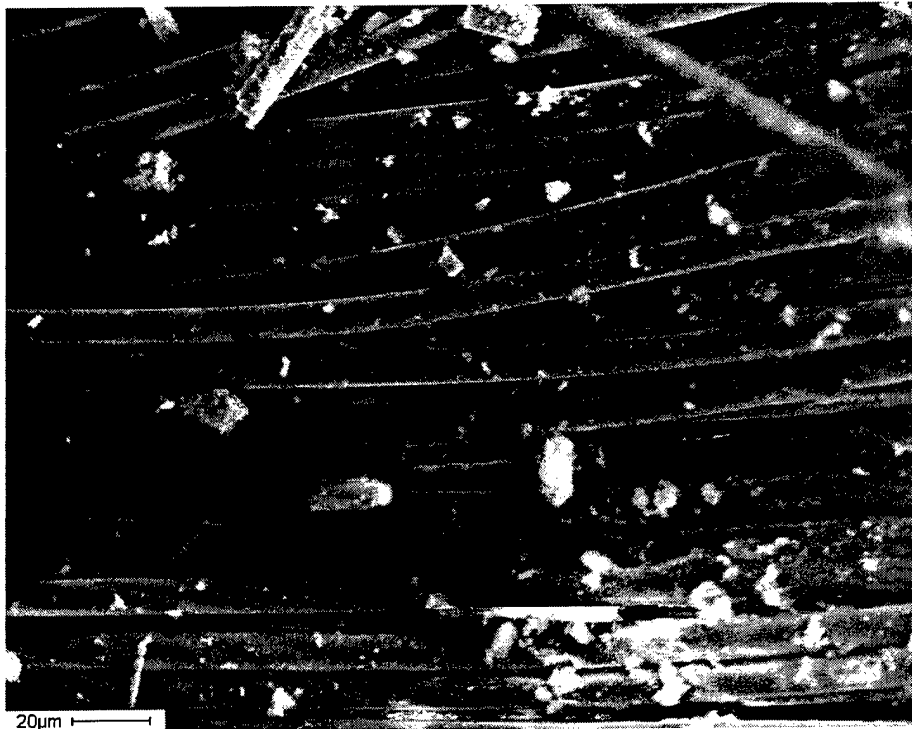
Figure 12. SEM photograph of fibers from silica phenolic liner of test fired thrust chamber.

Figures 12 and 13 are SEM photographs of the glass fibers from the silica phenolic and glass fabric overwrap, respectively. The fibers from both materials are similar in size and appearance with the fibers from the debris. Figures 14 and 15 present the EDX spectra of the glass fibers from the silica phenolic and glass fabric overwrap, respectively. It can be seen that the fibers from the silica phenolic contain only silicon and oxygen, indicating that they were not the source of the debris. However, the spectrum of the overwrap fibers contains oxygen, silicon, calcium, and aluminum, and is nearly identical to that of the debris fibers (Figure 8). Figure 16 compares the debris with the fabric from the overwrap. The weave pattern in each is very similar.
